# Nixalite® Project Case History

**Name:** Travis Air Force Base

**Location:** Travis AFB, CA

**Purpose:** To augment BASH Control (Bird to Aircraft Strike Hazard) for Travis Air Force Base by reducing the number of bird perches around aircraft runways.

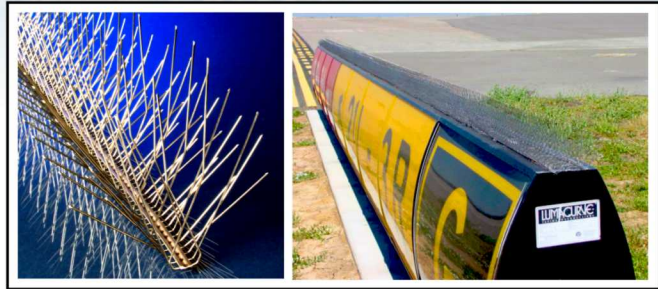
Premium Nixalite Model S (left) installed on runway directional signs (right).

WCT installed 1,300 feet of Premium Model S Nixalite on top of the taxiway signs. The installation called for 1,200 of Nixalite's proprietary Glue Clips. "Using Nixalite's Glue Clips allows for the option of removing the spikes for sign maintenance, which is preferable to gluing down the strips directly. The clips are of marine grade stainless steel and one clip can join two Nixalite spike strips together. We used adhesive to fasten the clips, which can also be fastened with nails or screws," said Horton.
